Mays Consulting & Evaluation Services, Inc.

INFRARED THERMOGRAPHIC SURVEY

JANUARY 30, 2009

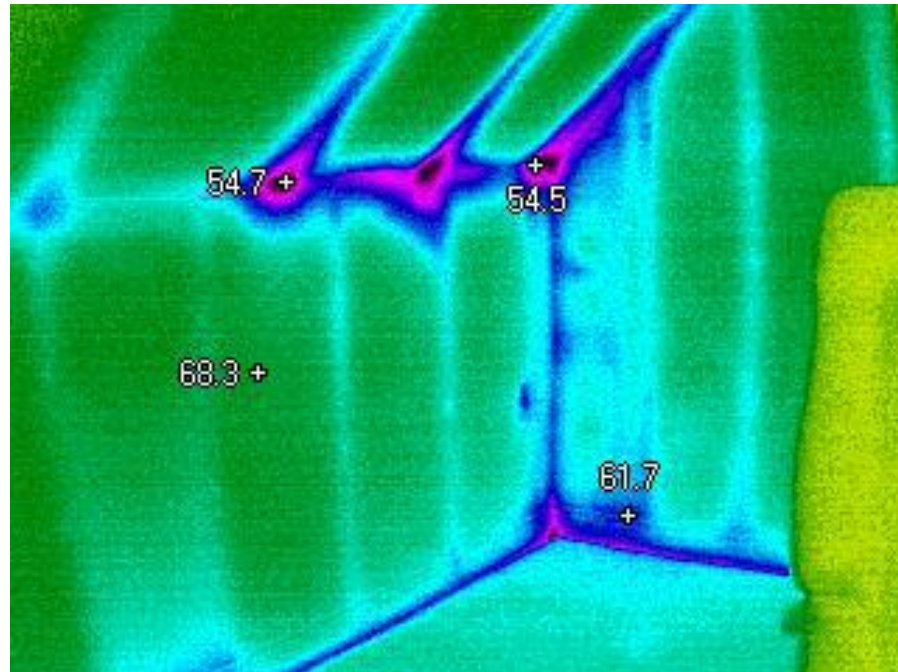
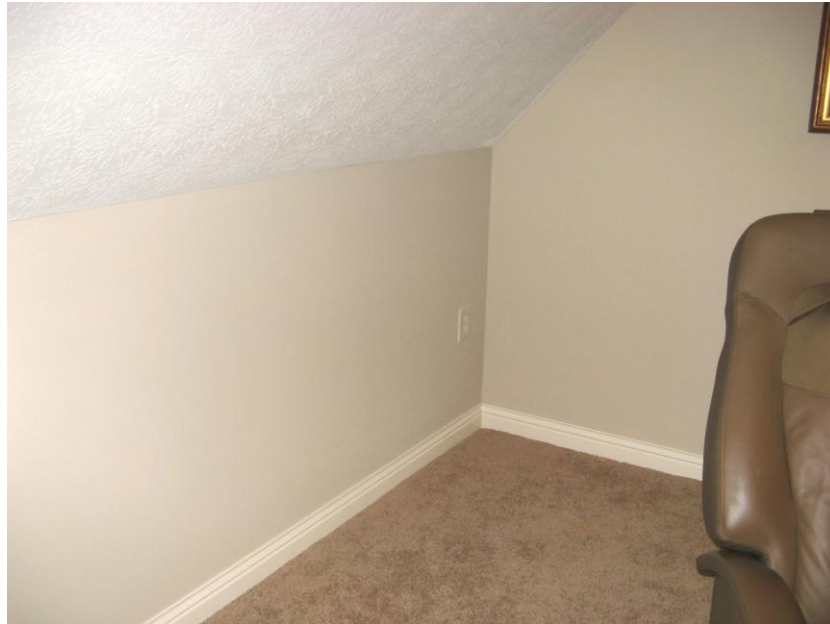
Illustration #1

Cold exterior air infiltration was identified in several locations within the Bonus Room located above the garage. The cause appears to be exterior air infiltration occurring through insulation gaps at the top of the knee walls. In addition, air infiltration was also identified at the floor line-to-knee wall intersection on the west elevation (see illustrations #1 thru #5).

- A. Thermogram indicates cold air infiltration at top of knee wall elevation. Note surface temperature variations.

- B. Photograph indicates area in which above thermogram was recorded - Bonus Room, east elevation.

The insulation installation should be reviewed and corrected where accessible. In addition the gap below the floor line-to-knee wall intersection should be sealed.

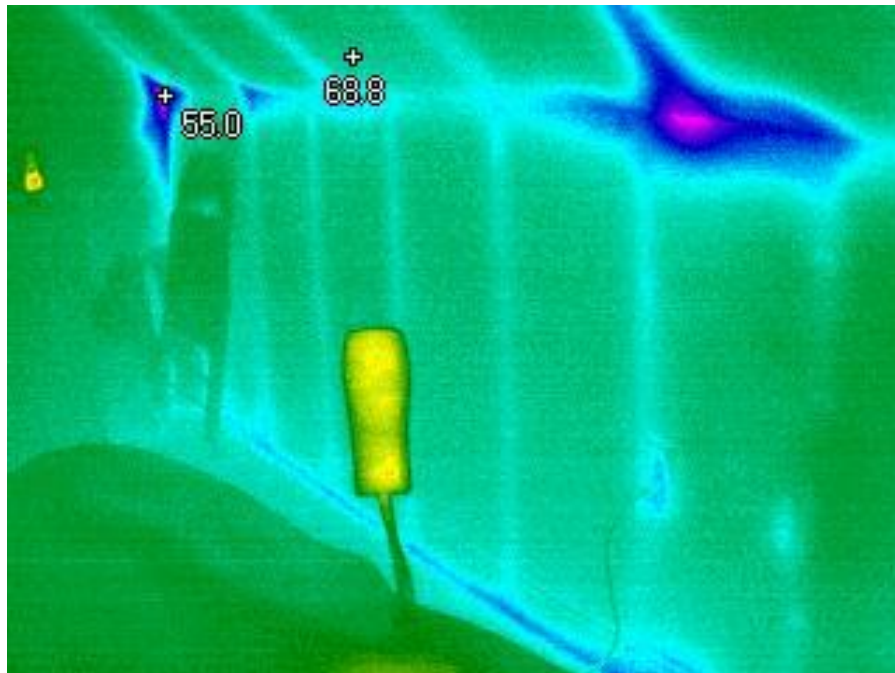
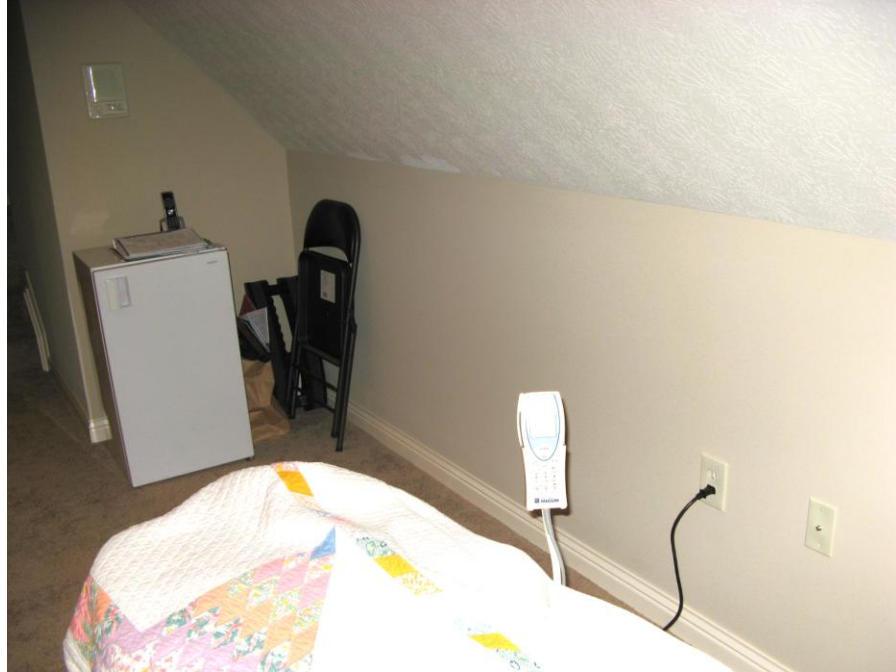
Illustration #2

- A. Thermogram indicates cold air infiltration at top and bottom of knee wall elevation. Note surface temperature variations.

B. Photograph indicates area in which above thermogram was recorded - Bonus Room, east elevation.

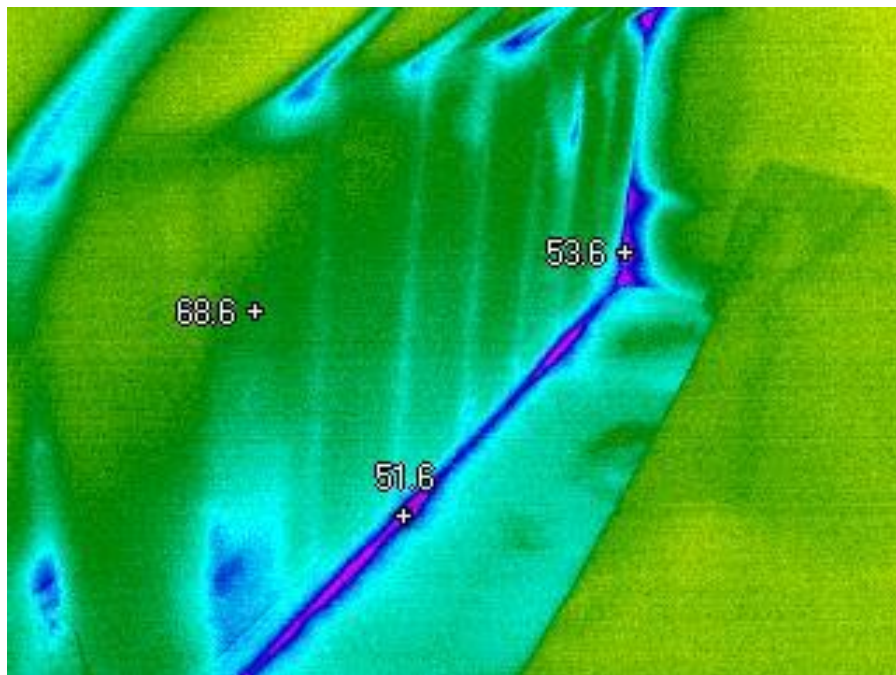
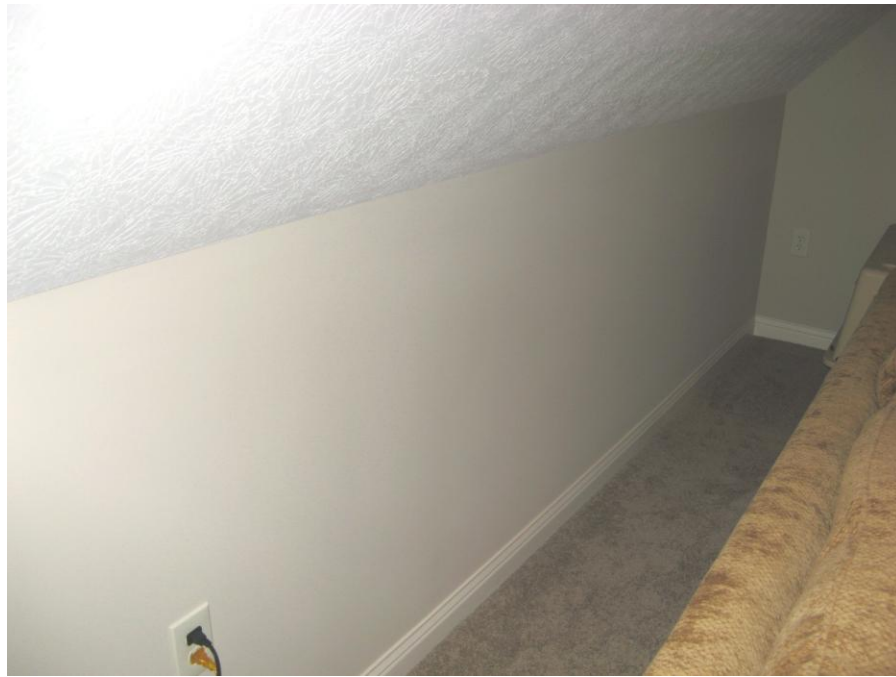
Illustration #3

A. Thermogram indicates cold air infiltration at top and bottom of knee wall elevation. Note surface temperature variations.

B. Photograph indicates area in which above thermogram was recorded - Bous Rom, west elevation.

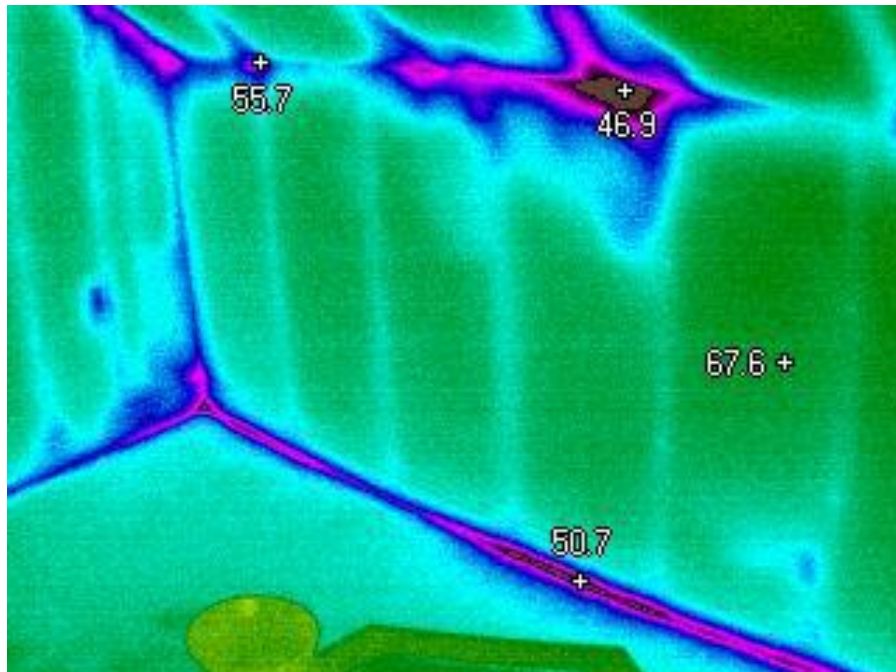
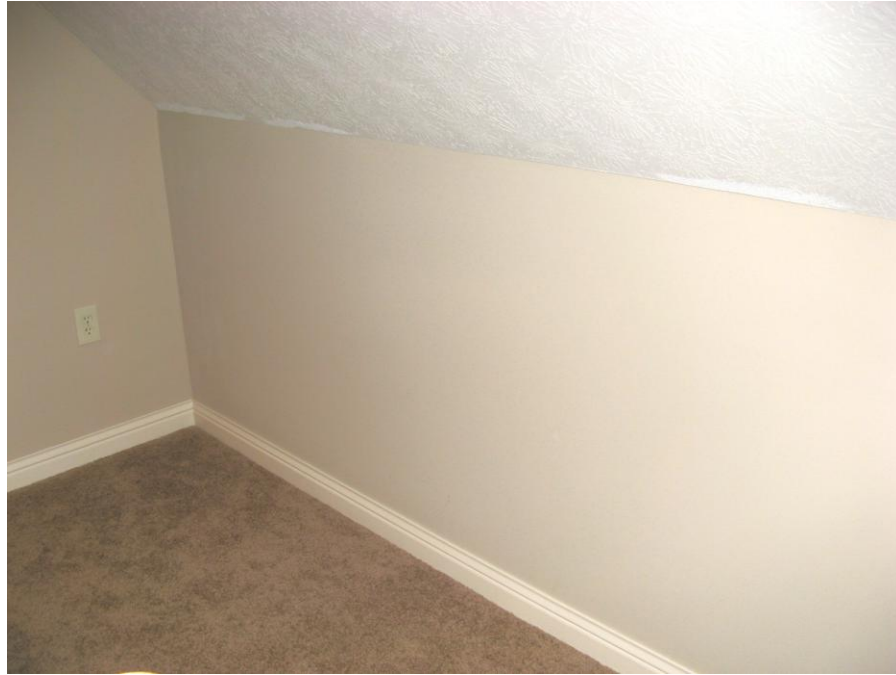
Illustration #4

- A. Thermogram indicates cold air infiltration at top and bottom of knee wall elevation. Note surface temperature variations.

- B. Photograph indicates area in which above thermogram was recorded - Bonus Room, west elevation.

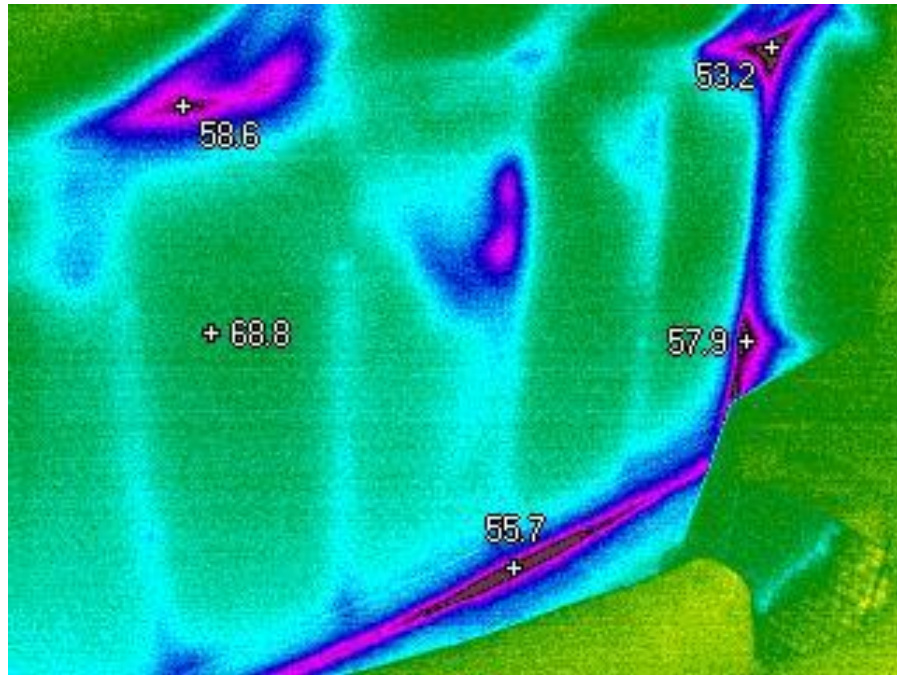
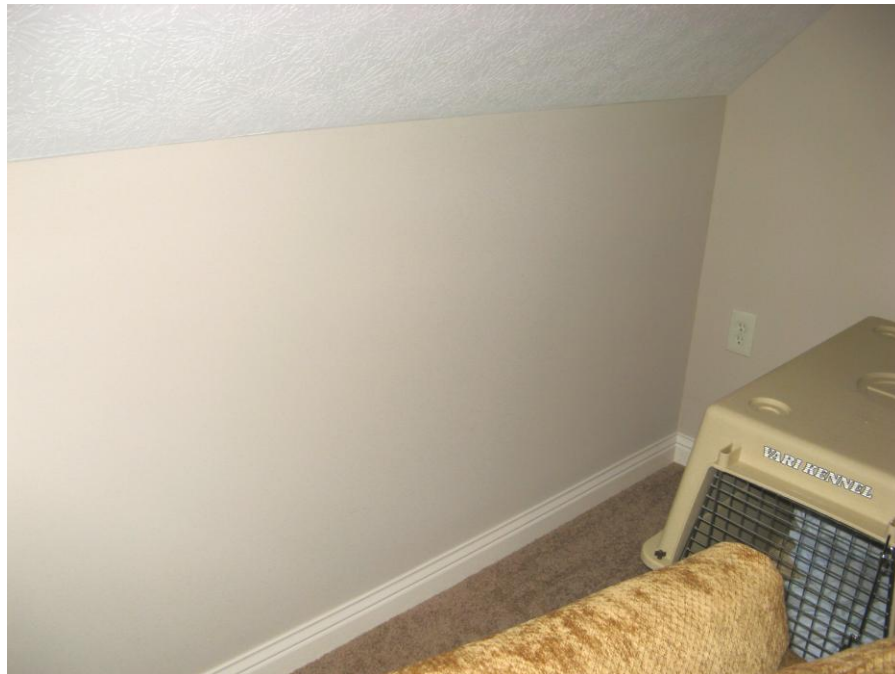
Illustration #5

- A. Thermogram indicates cold air infiltration at top and bottom of knee wall elevation. Note surface temperature variations.

- B. Photograph indicates area in which above thermogram was recorded - Bonus Room, west elevation.

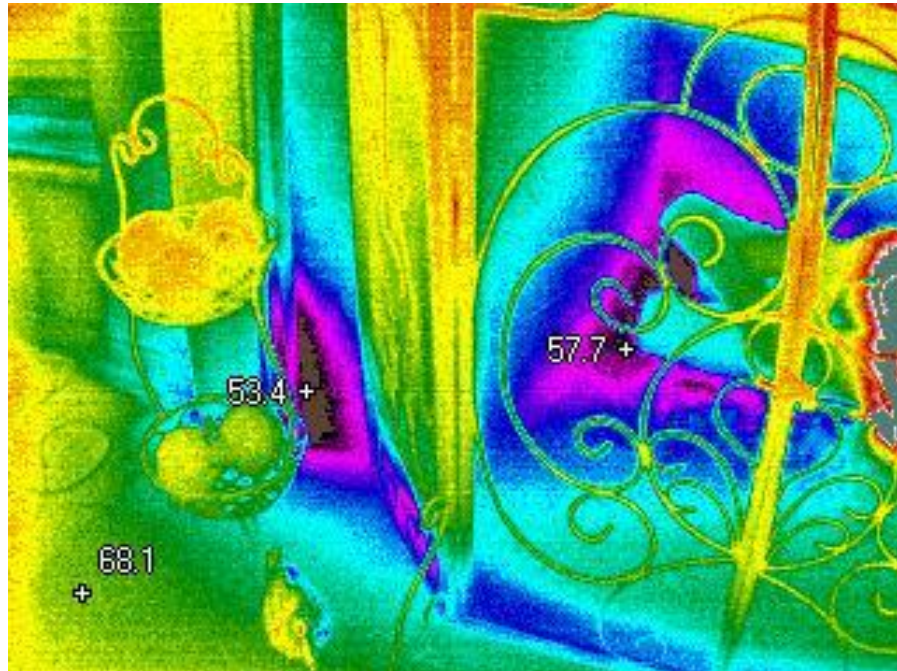
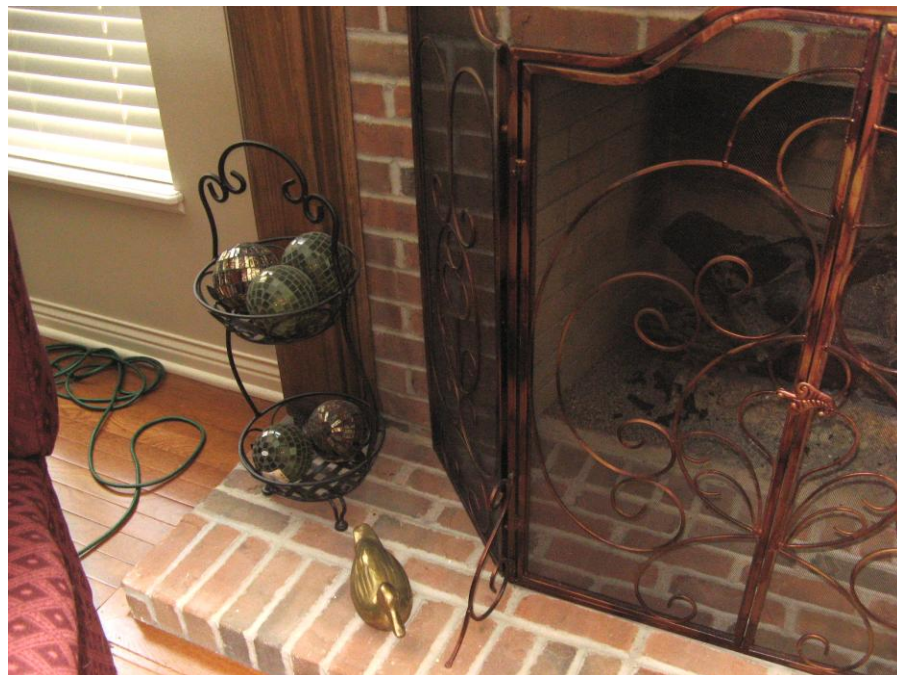
Cold exterior air infiltration was identified within both the Great Room fireplace and at the base of the Kitchen bay window and adjoining floor area (see illustrations #6 and #7). Both locations include similar cantilevered framing details, which protrude from the north wall elevation.

A. Thermogram indicates cold air infiltration occurring around cantilevered fireplace detail. Note surface temperatures.

B. Photograph indicates area in which above thermogram was recorded - Living Room, north elevation.

The insulation installation below the cantilevered areas should be reviewed and corrected as necessary. Any gaps should be sealed to prevent air infiltration from occurring

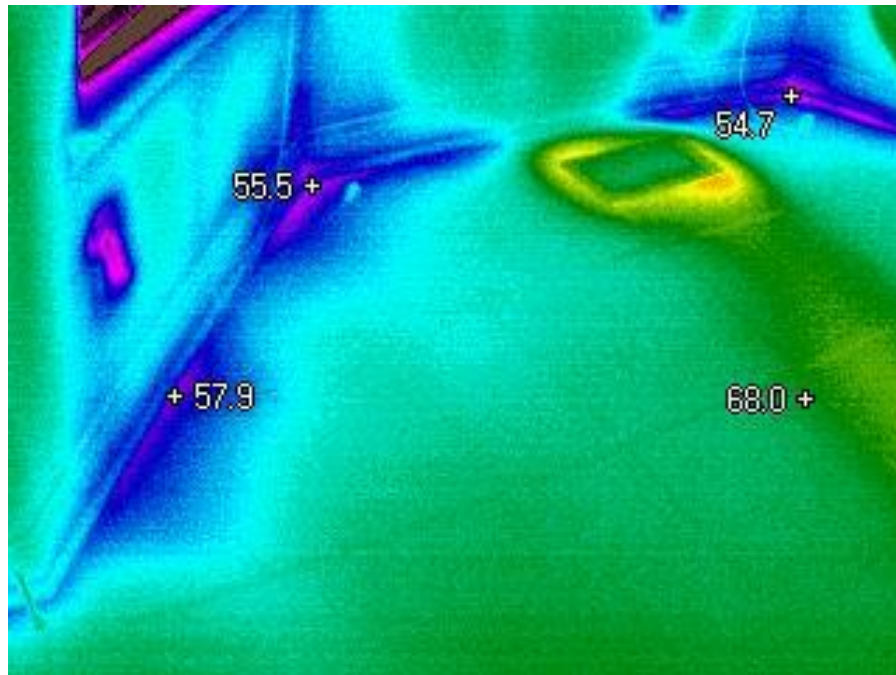
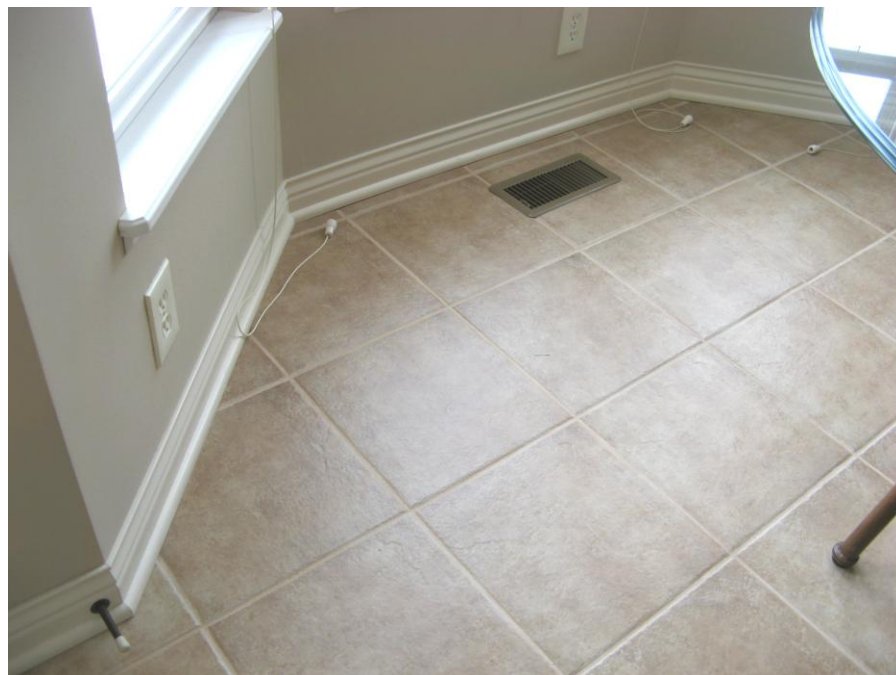
Illustration #7

- A. Thermogram indicates cold air infiltration occurring under floor of cantilevered bay window detail. Note surface temperatures.

- B. Photograph indicates area in which above thermogram was recorded - Kitchen, north elevation.

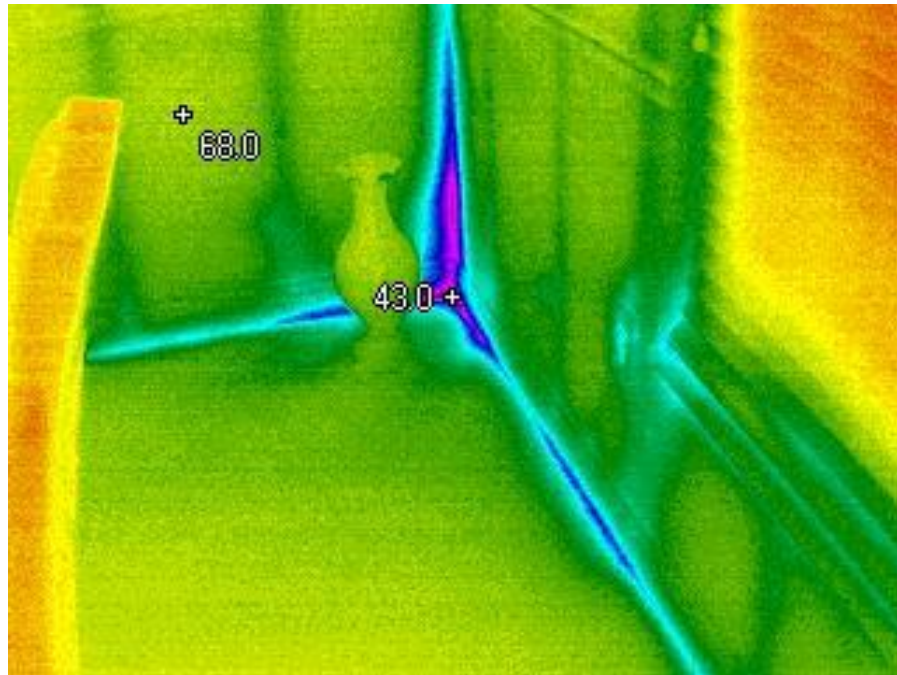
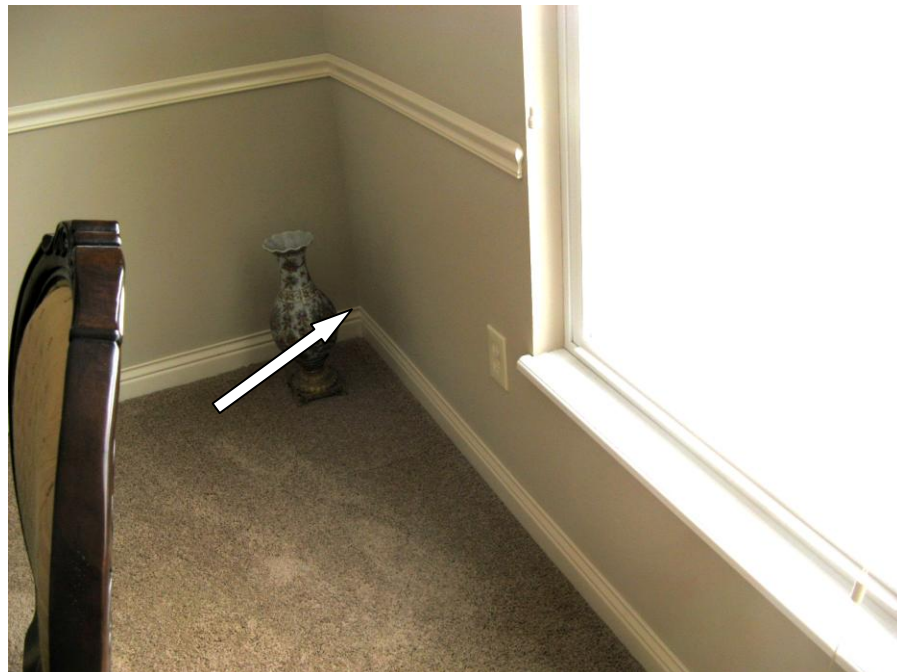
Illustration #8

Cold exterior air penetration was observed within the basement band board cavities at numerous locations. The fiberglass batt insulation as installed is not uniform and poorly installed, allowing cold exterior air to enter through the band board framing details See illustration pages #8 thru #15).

- A. Thermogram indicates cold air infiltration, which appears to be originating through Basement band board. Note surface temperatures.

- B. Photograph indicates area in which above thermogram was recorded - Dining Room, southeast corner..

Any voids within the band board framing should be sealed using a quality monolithic sealant and or spray applied foam. This includes any utility penetrations. The band board framing should then be thoroughly insulated using fiberglass batt insulation.

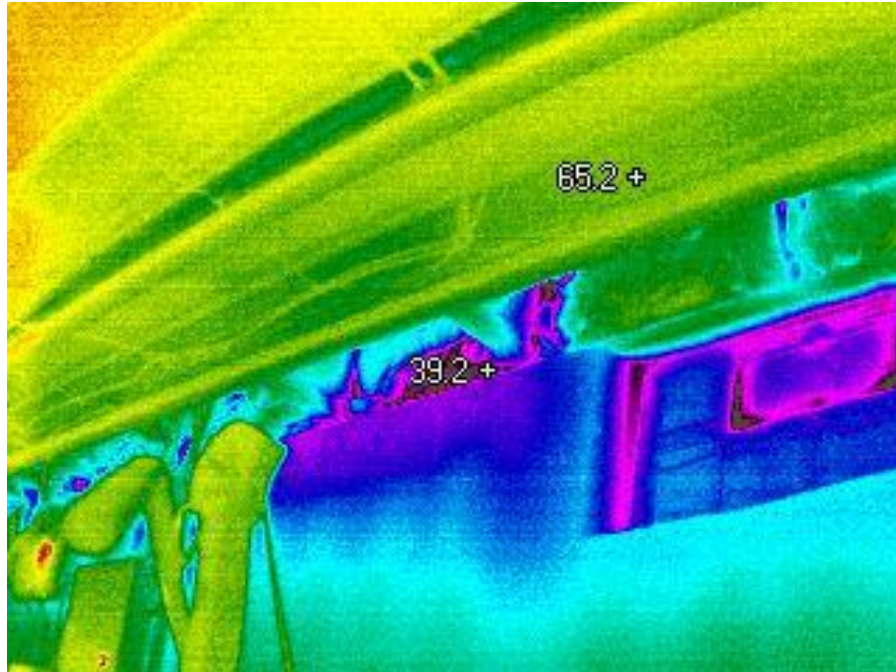
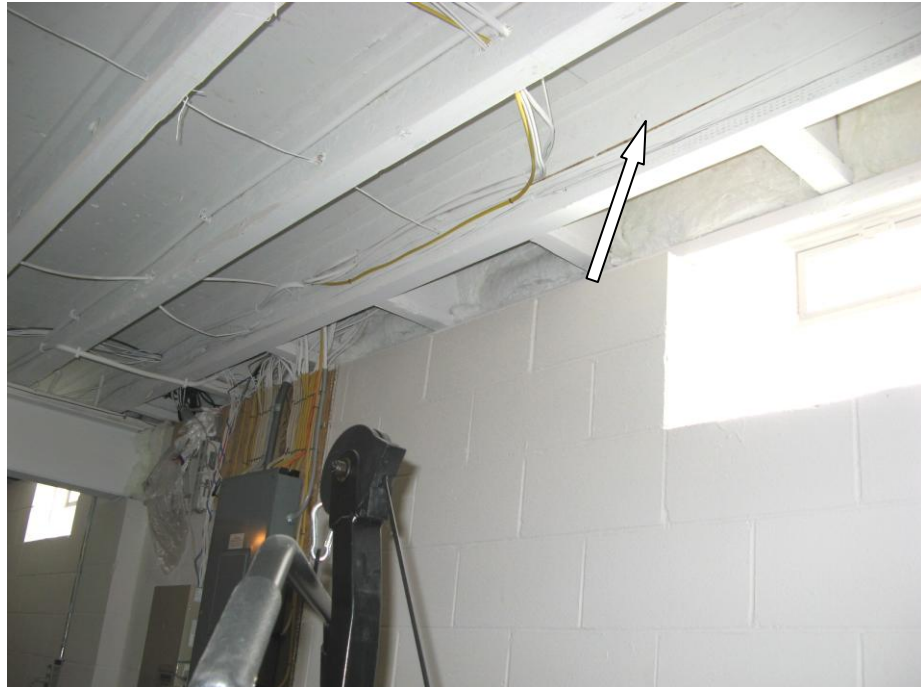
Illustration #9

- A. Thermogram indicates cold air infiltration which is entering through Basement band board. Note surface temperatures.

- B. Photograph indicates area in which above thermogram was recorded - Basement, east wall.

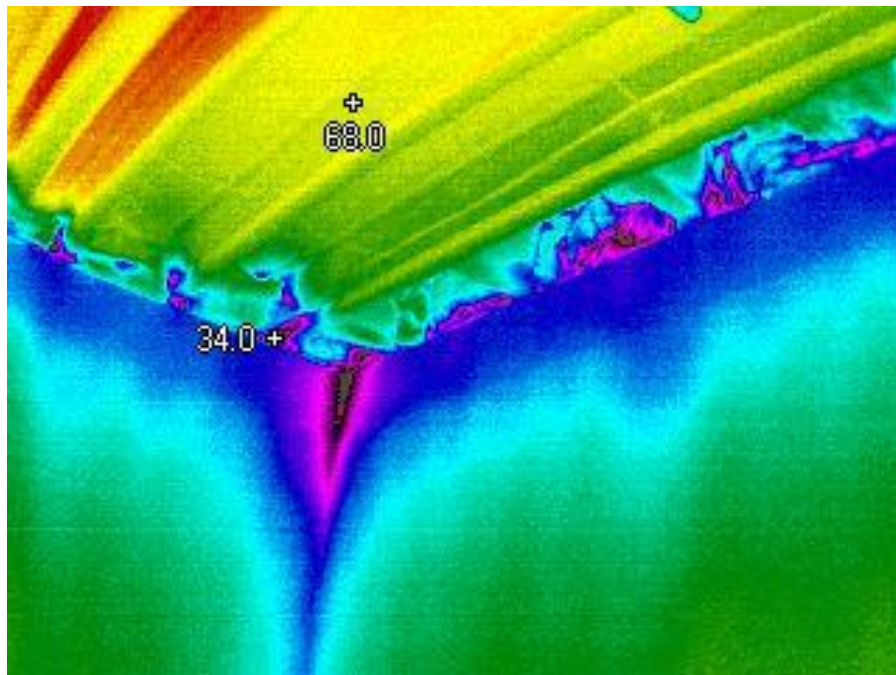
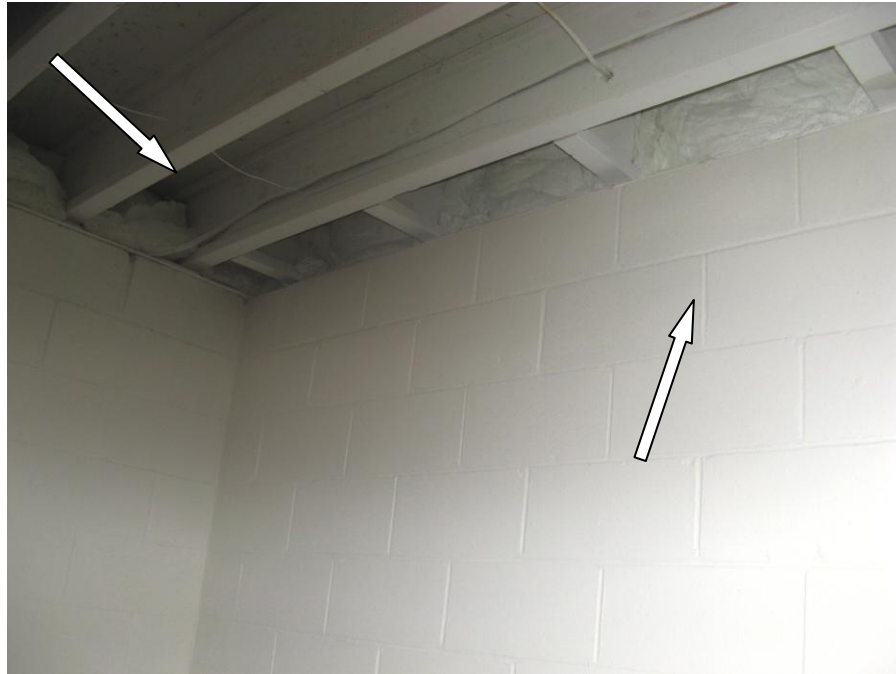
Illustration #10

- A. Thermogram indicates cold air infiltration which is entering through Basement band board. Note surface temperatures.

B. Photograph indicates area in which above thermogram was recorded - Basement, east wall.

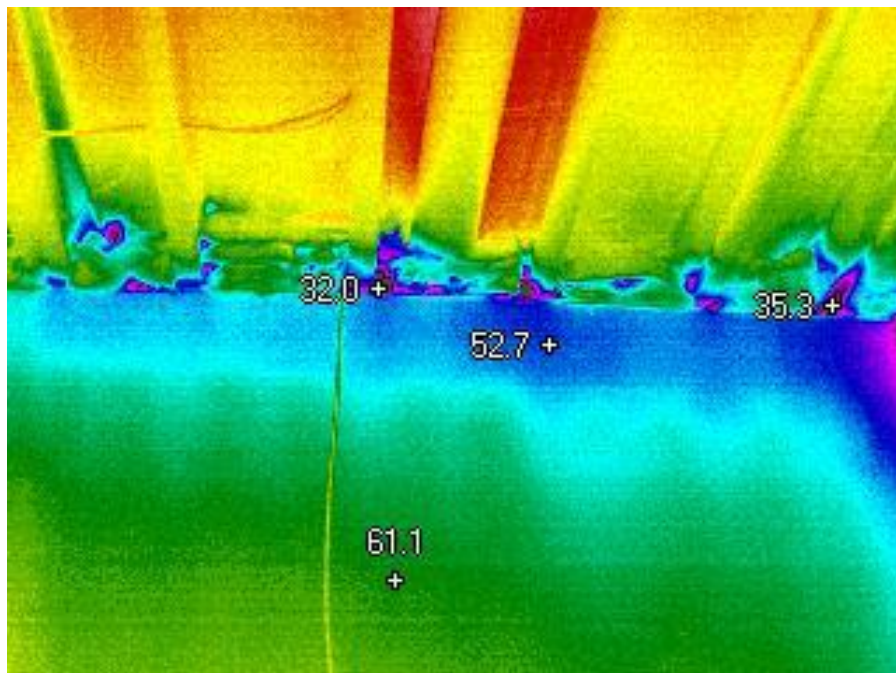
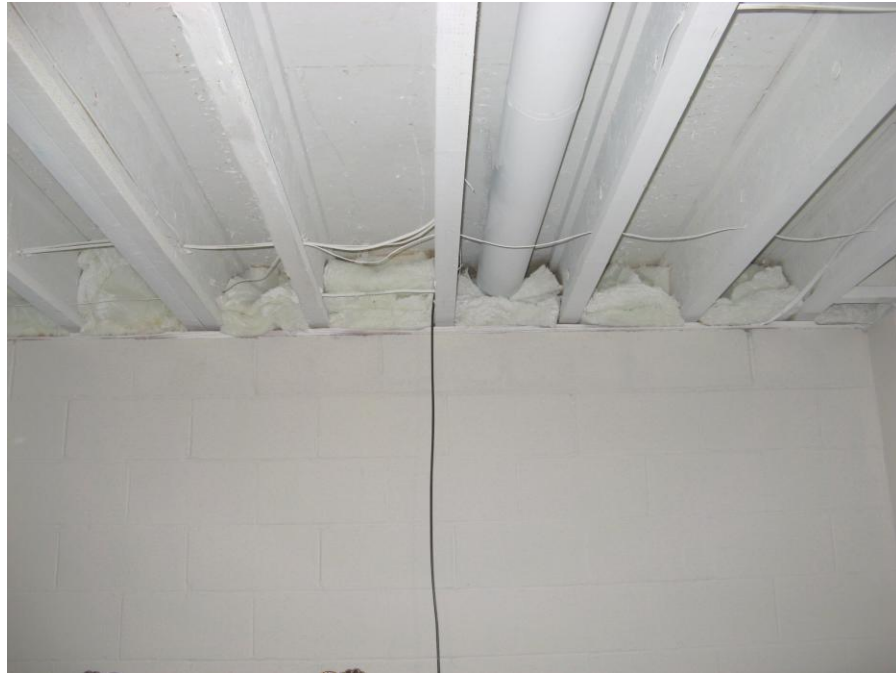
Illustration #11

A. Thermogram indicates cold air infiltration which is entering through Basement band board. Note surface temperatures.

- B. Photograph indicates area in which above thermogram was recorded -
Basement, north wall.

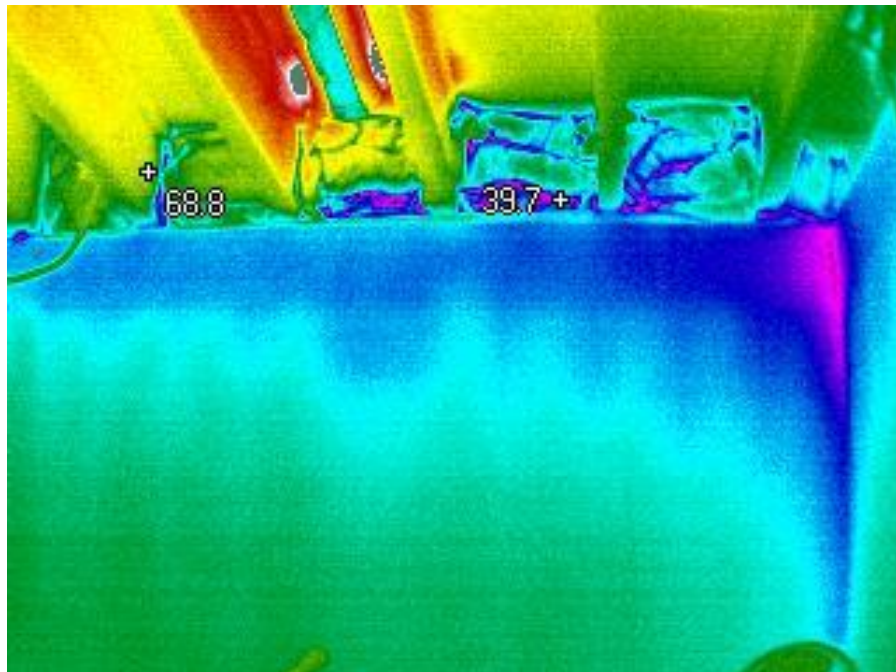
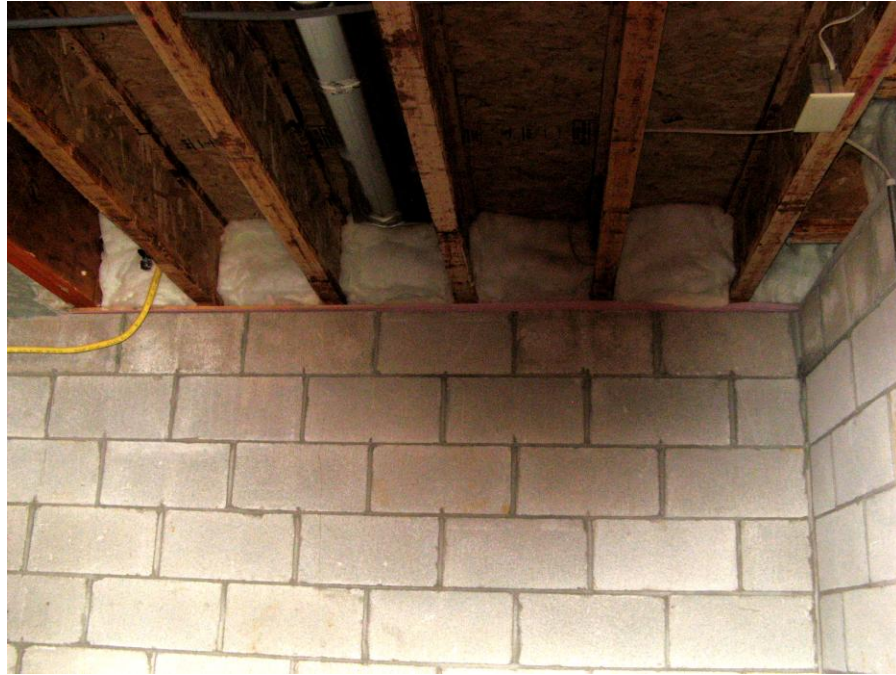
Illustration #12

- A. Thermogram indicates cold air infiltration which is entering through Basement band board. Note surface temperatures.

- B. Photograph indicates area in which above thermogram was recorded - Basement, north wall.

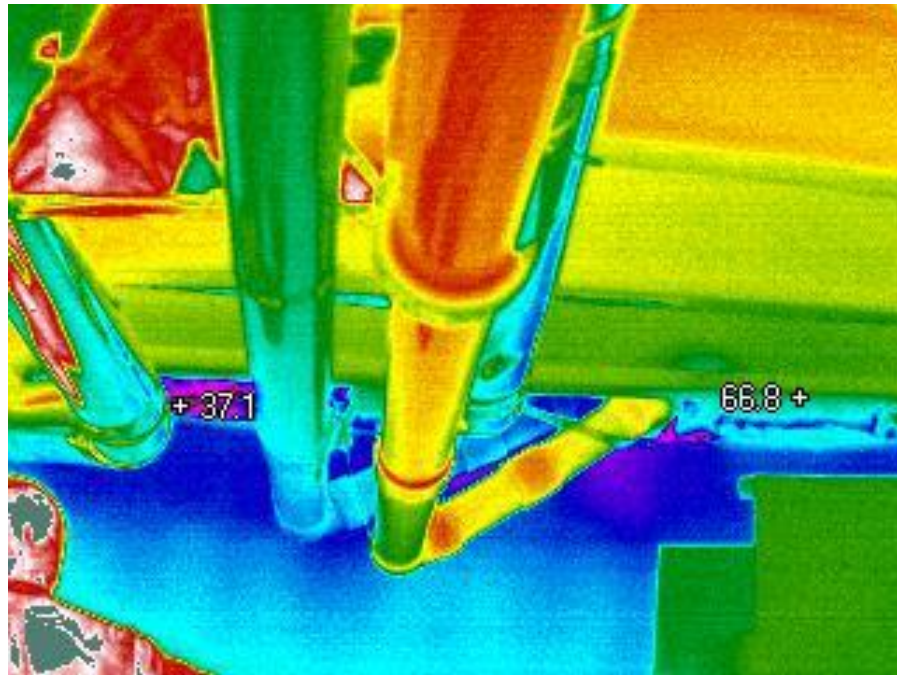
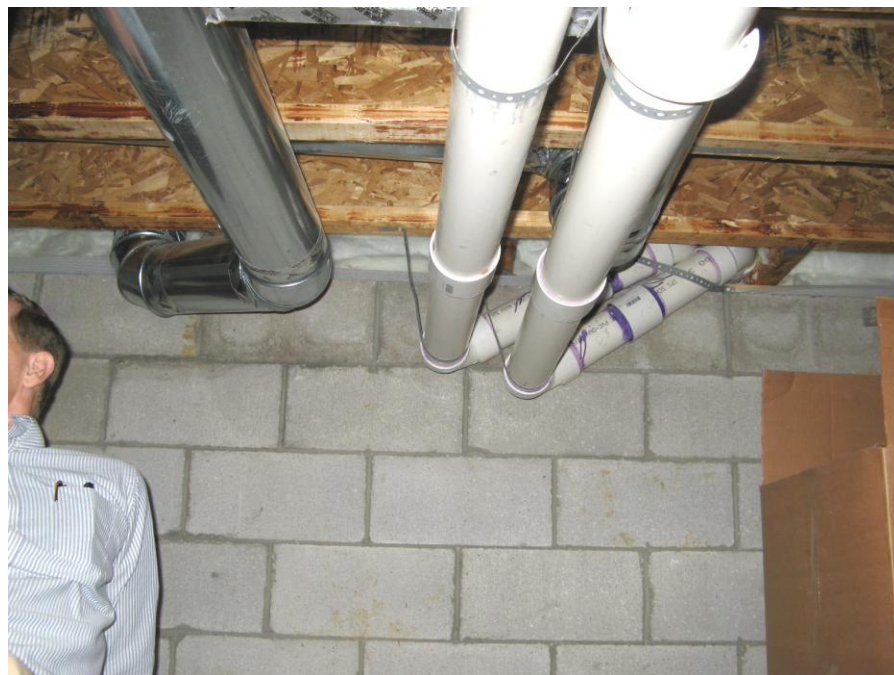
Illustration #13

A. Thermogram indicates cold air infiltration which is entering through Basement band board. Note surface temperatures.

B. Photograph indicates area in which above thermogram was recorded - Basement, west wall.

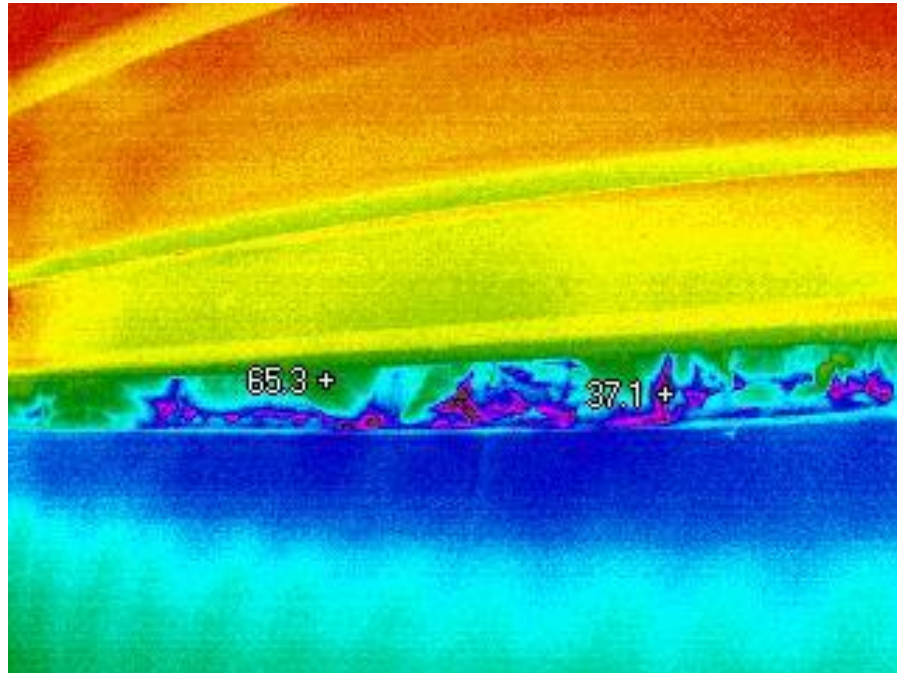
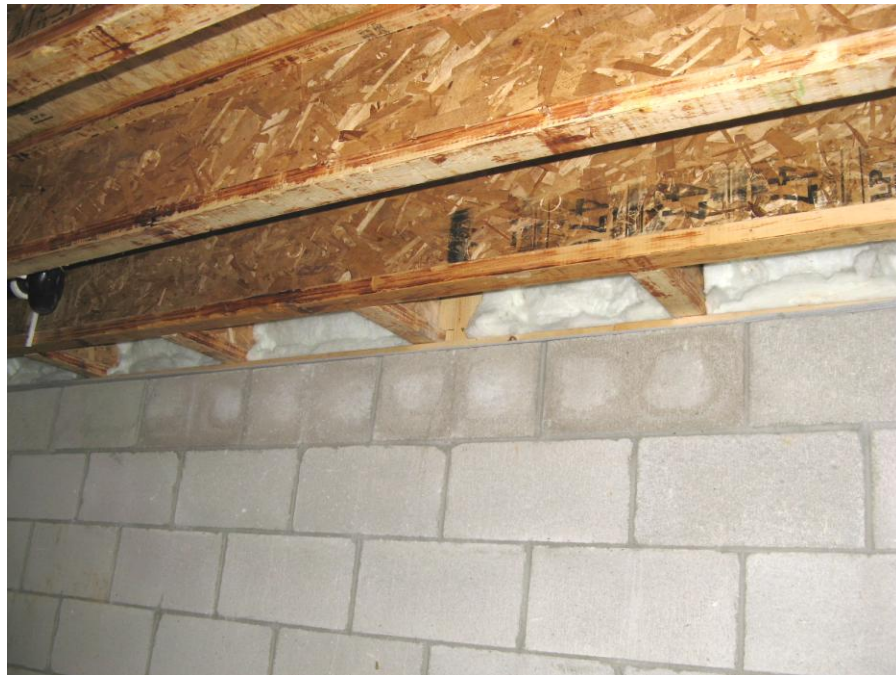
- A. Thermogram indicates cold air infiltration which is entering through Basement band board. Note surface temperatures.

- B. Photograph indicates area in which above thermogram was recorded - Basement, west wall.

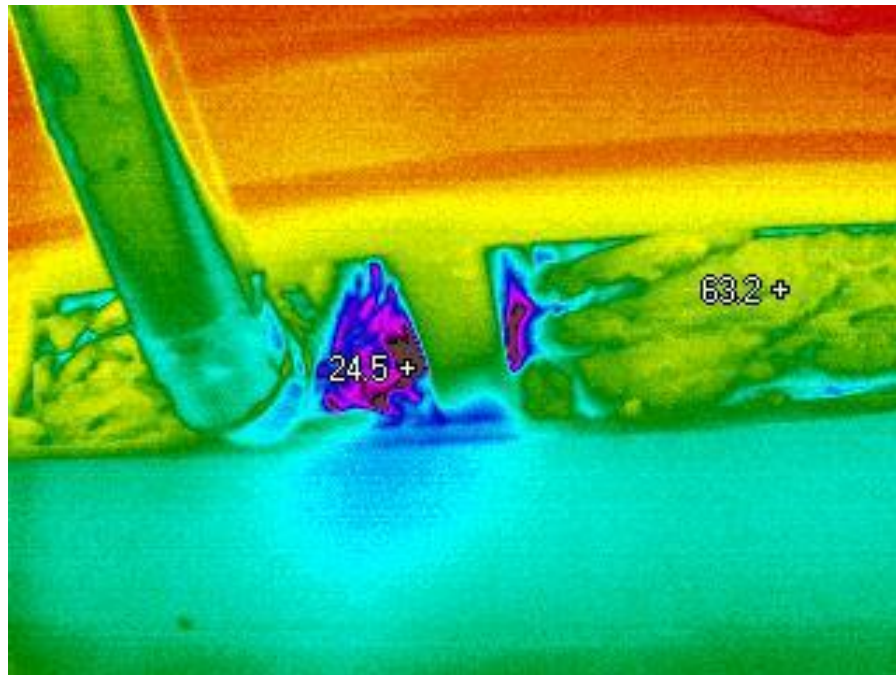
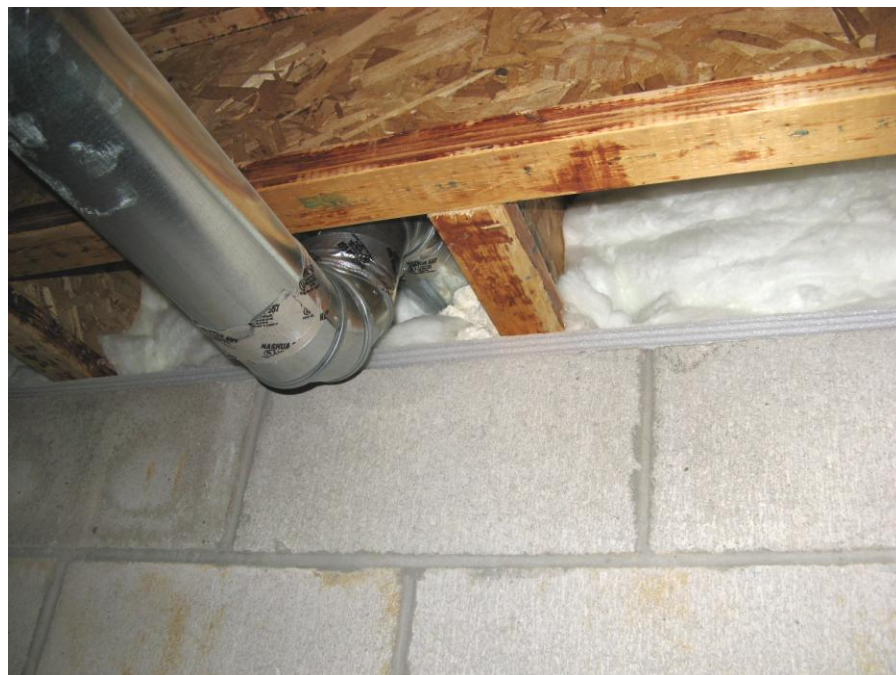
Illustration #15

- A. Thermogram indicates cold air infiltration which is entering through Basement band board. Note surface temperatures.

- B. Photograph indicates area in which above thermogram was recorded - Basement, west wall.

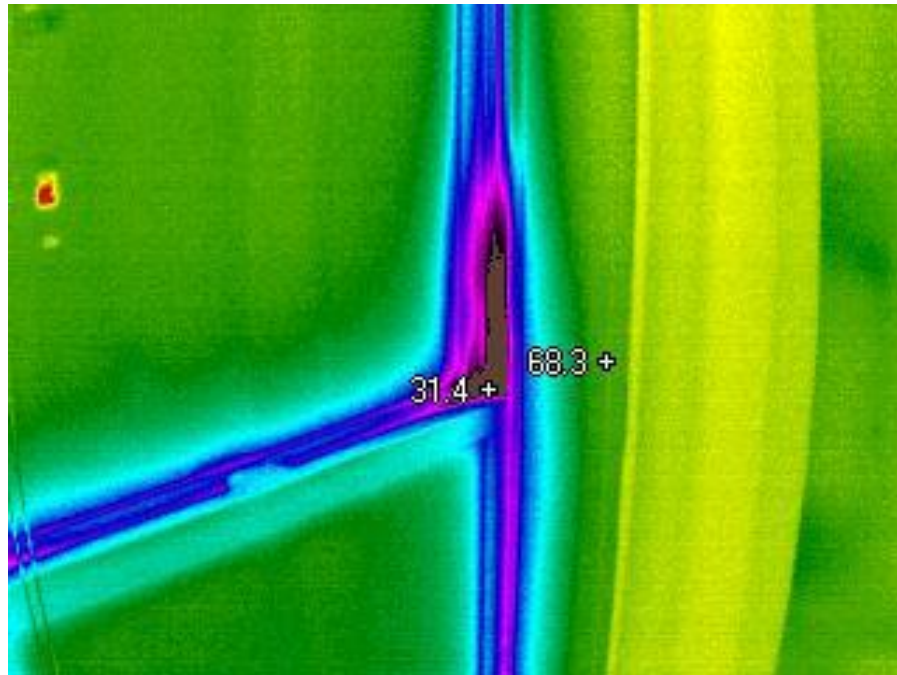
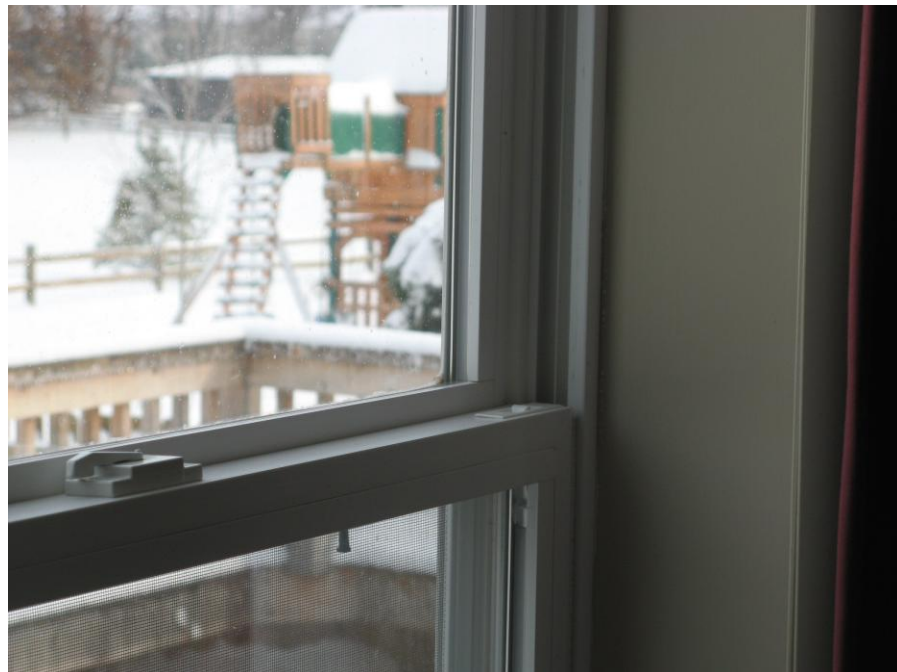
Illustration #16

Cold exterior air infiltration was identified within the window frame details at three (3) locations within the residence. These locations include Great Room-lower right side window, Den-lower right side window and Master Bath window (see illustrations #16 thru #18).

- A. Thermogram indicates cold air infiltration which is entering through a poorly sealed window detail. Note surface temperatures.

- B. Photograph indicates area in which above thermogram was recorded - Great Room, north wall.

The affected, poorly sealing window framing details should be reviewed and repaired as required.

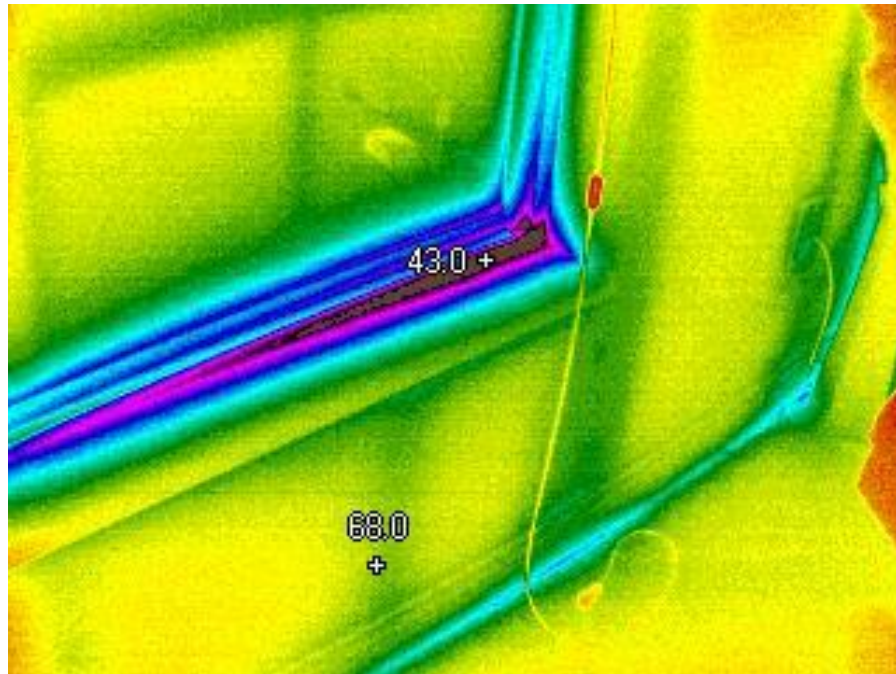
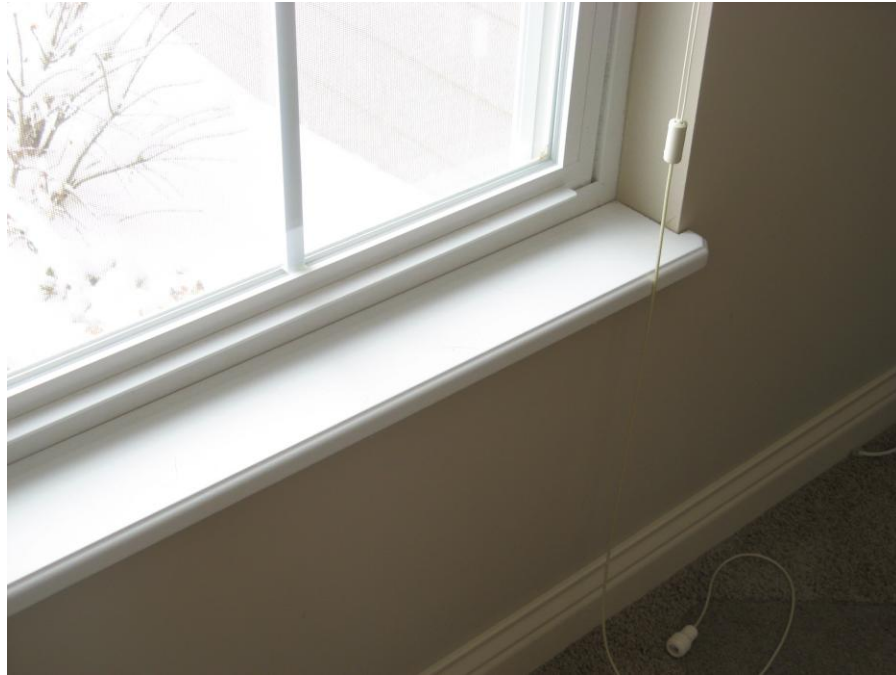
Illustration #17

- A. Thermogram indicates cold air infiltration which is entering through a poorly sealed window detail. Note surface temperatures.

- B. Photograph indicates area in which above thermogram was recorded - Den, south wall.
