Mays Consulting & Evaluation Services, Inc.

INFRARED THERMOGRAPHIC SURVEY

JANUARY 30, 2009

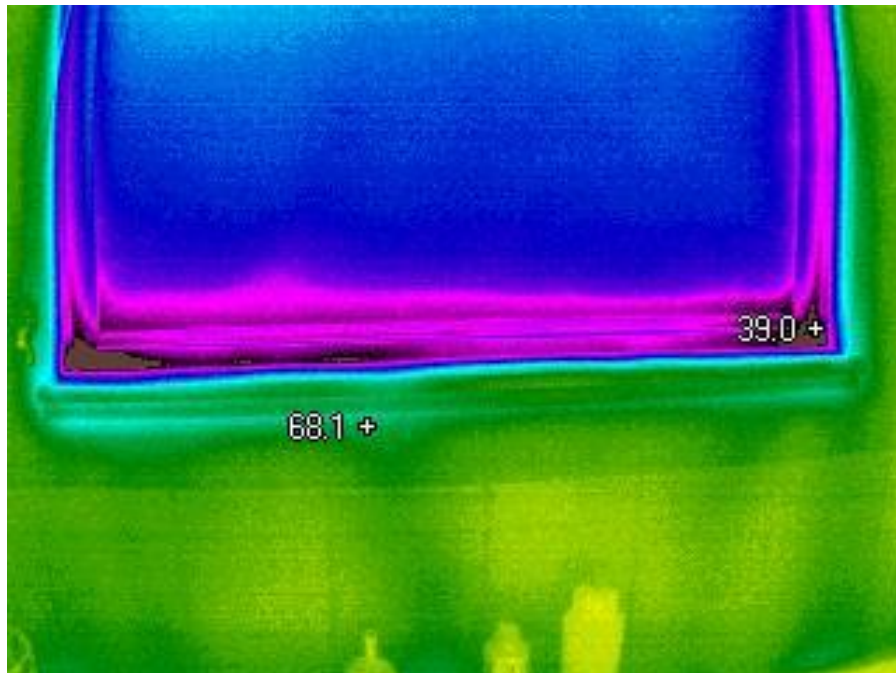
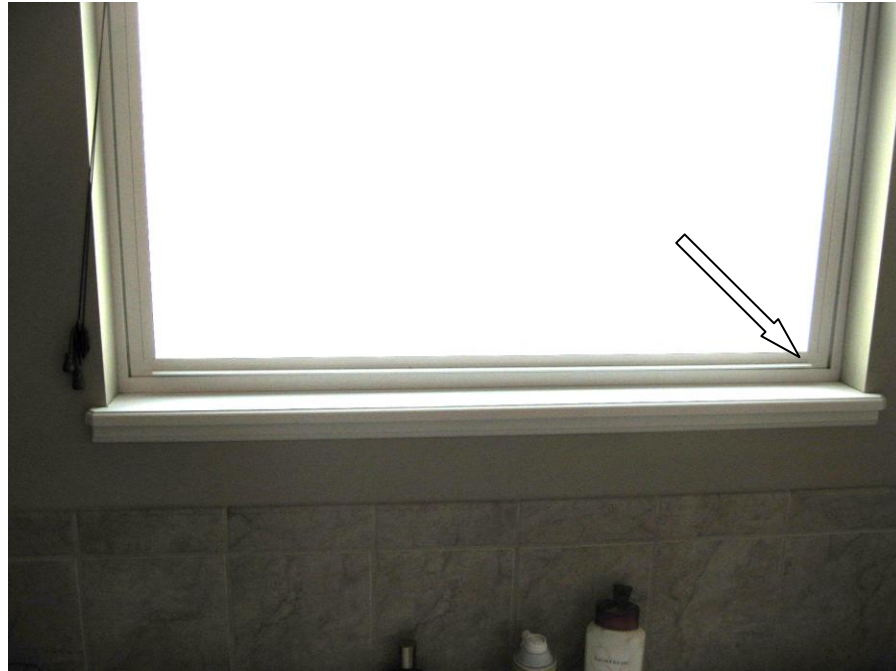
Illustration #18

Cold exterior air infiltration was identified within the window frame details at three (3) locations within the residence. These locations include Great Room-lower right side window, Den-lower right side window and Master Bath window (see illustrations #16 thru #18).

- A. Thermogram indicates cold air infiltration which is entering through a poorly sealed window detail. Note surface temperatures.

- B. Photograph indicates area in which above thermogram was recorded - Master Bath, west wall.

The affected, poorly sealing window framing details should be reviewed and repaired as required.

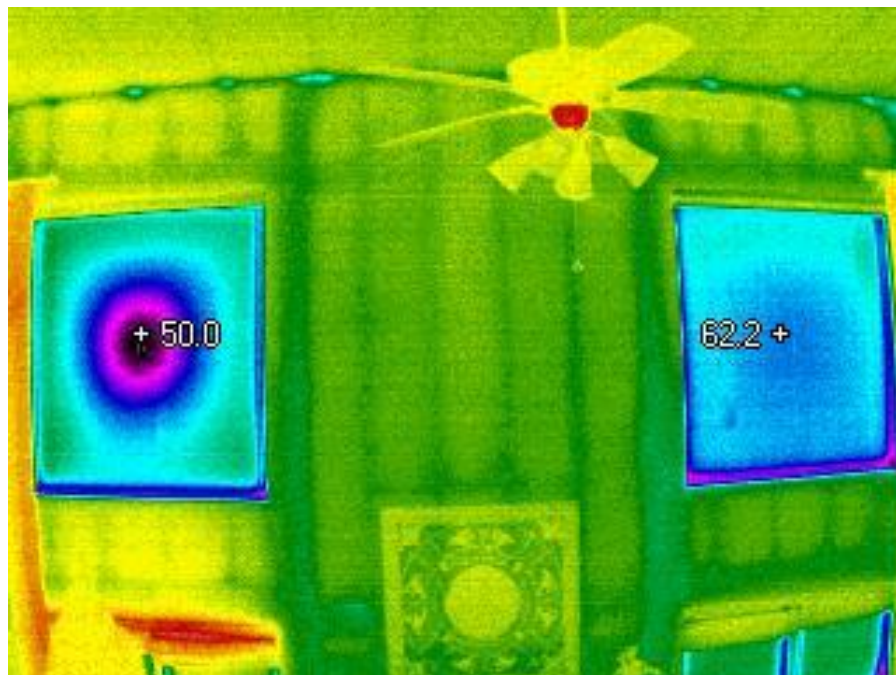
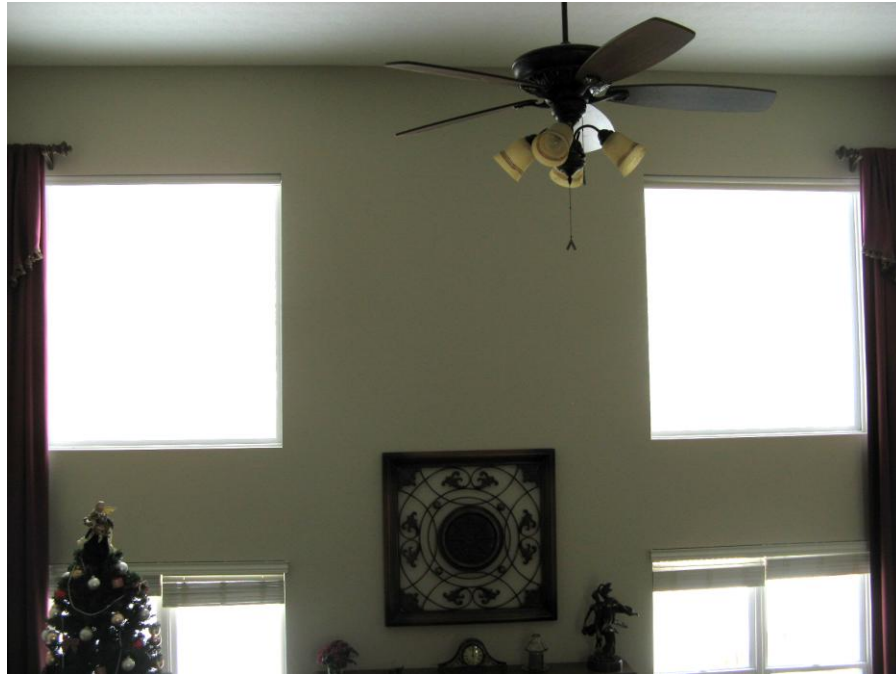
Illustration #19

The upper left side window within the Great Room north elevation was found to have a faulty seal (see illustrations #19 thru #22). As gas installed between the window pane leaks out through a faulty seal, the window panes compress, decreasing the R-value of the window. The result is substantially colder surface temperatures on the inside of the window in comparison to other like windows. This condition will also promote frost development on the inside of the window.

- A. Thermogram indicates damaged window seal within left window assembly.

B. Photograph indicates area in which above thermogram was recorded - Great Room, north elevation.

The window assembly should be replaced.

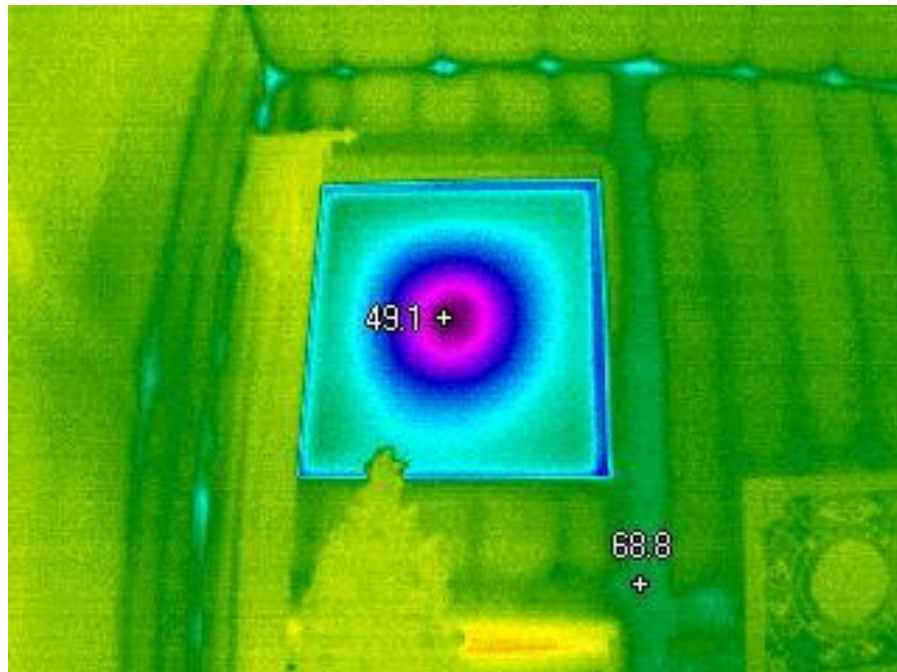
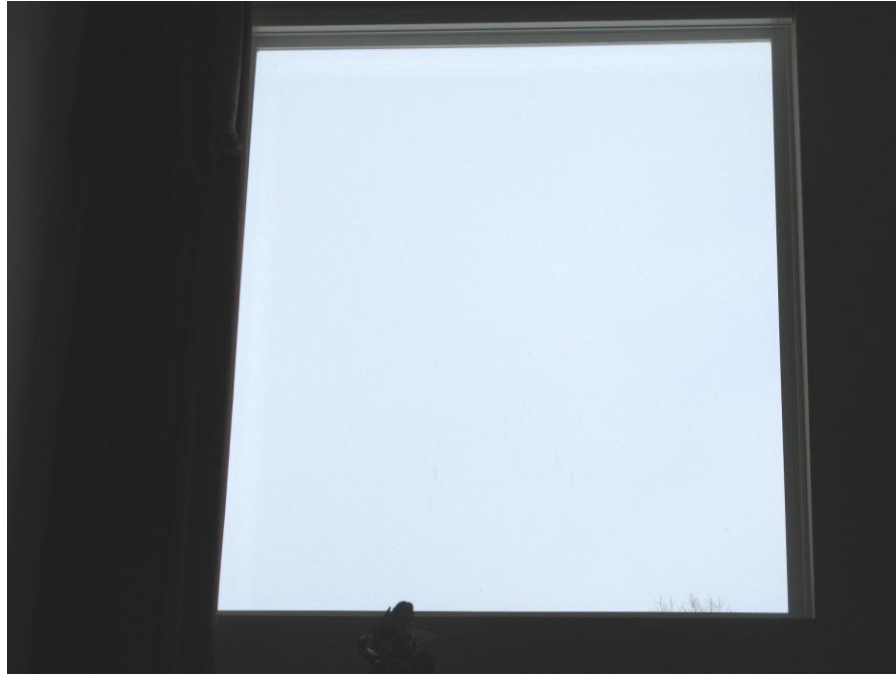
Illustration #20

- A. Thermogram indicates damaged window seal within upper left window assembly.

- B. Photograph indicates area in which above thermogram was recorded - Great Room, north elevation.

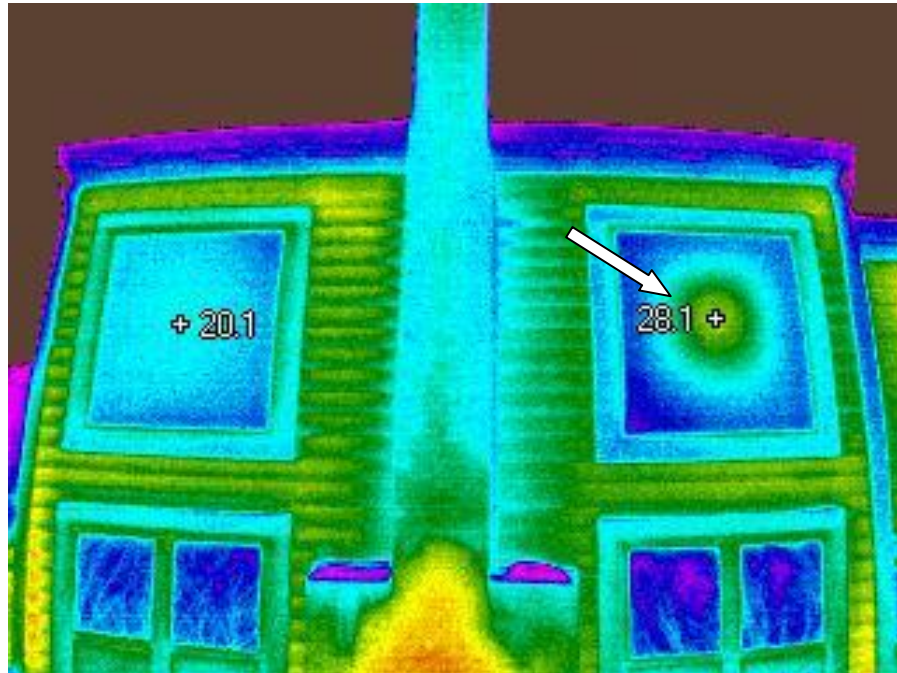
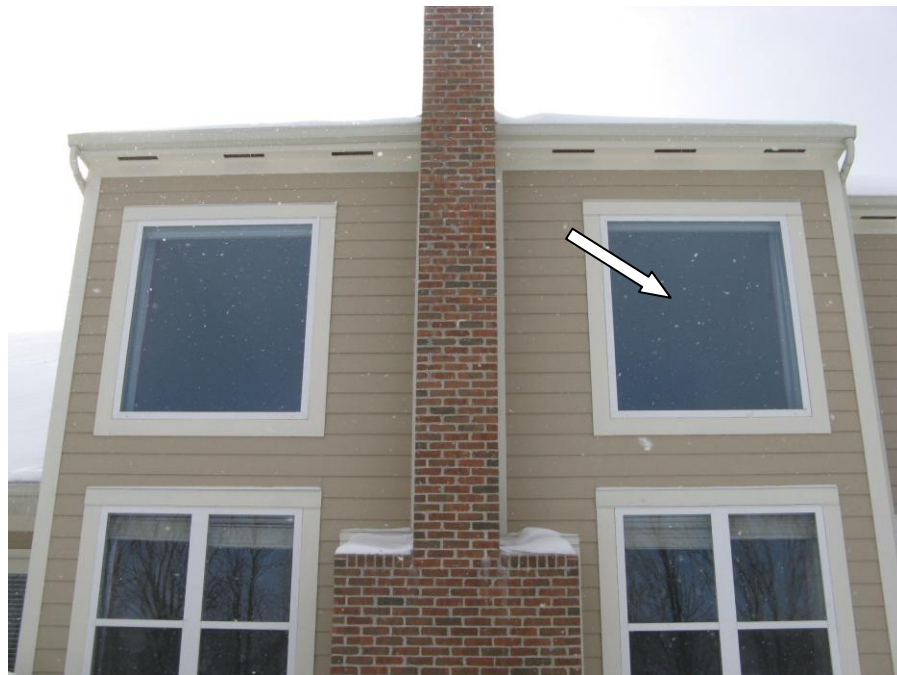
A. Thermogram indicates damaged window seal. Note image non-uniformity and surface temperature variations between windows.

B. Photograph indicates area in which above thermogram was recorded - exterior, north elevation.

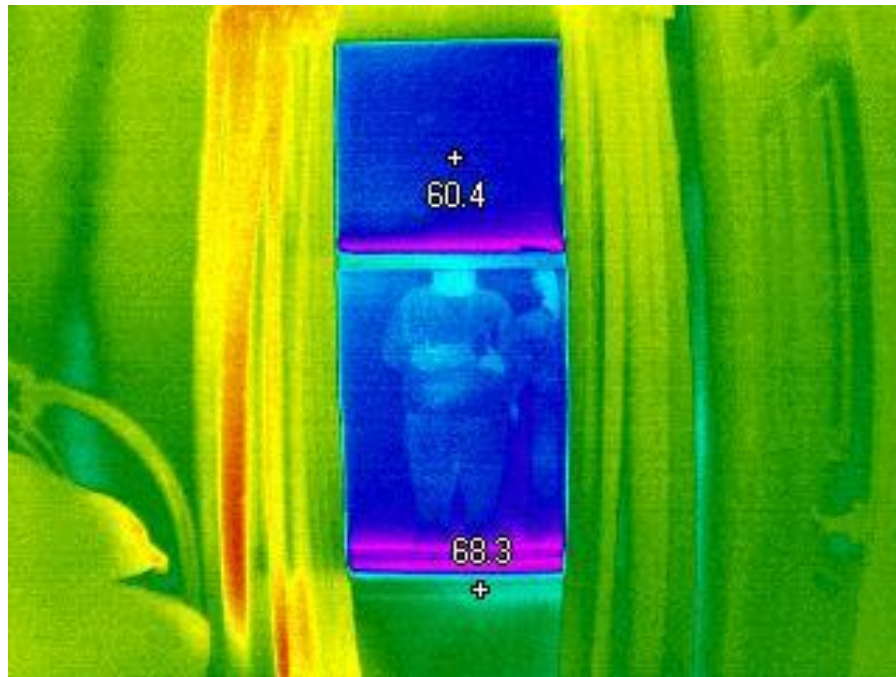
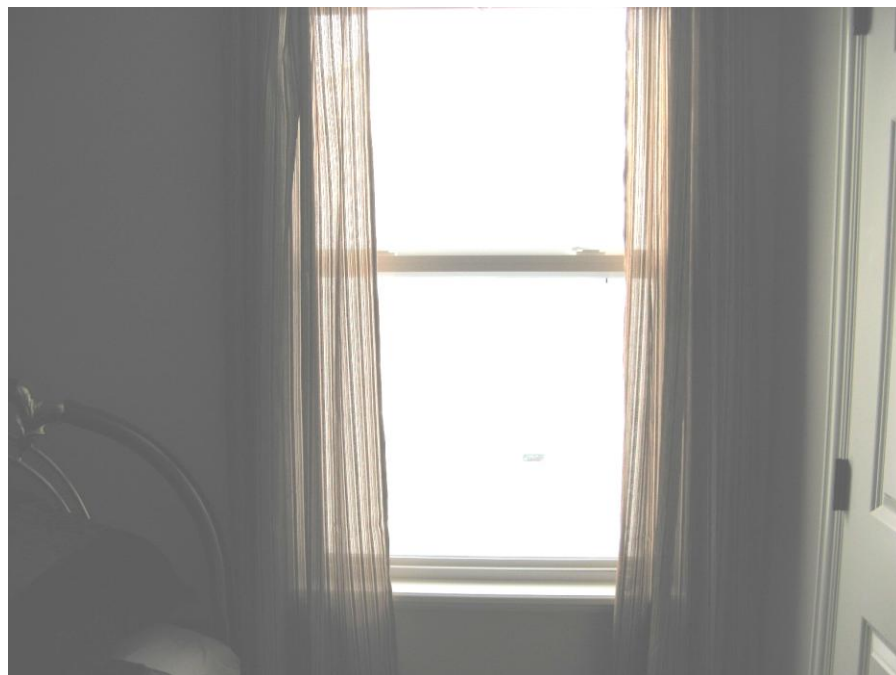
Illustration #23

Significant surface temperature differentials were identified within the window panes contained within two (2) window assemblies, in comparison to the surface temperatures of other like window assemblies installed at the residence. These locations include Bedroom #3 and Kitchen-east bay window (see illustrations #23 thru #25). The home owner indicated that the window assemblies identified were tested by others and do not contain low E (emittance) coating as specified. As thermal data contained within the illustrations indicate, the lack of the low E coating adversely affects the performance of the windows by allowing additional thermal transfer to occur.

- A. Thermogram indicates window with no low E coating. Compare surface temperature differentials with illustration #23.

- B. Photograph indicates area in which above thermogram was recorded - Bedroom #3, west elevation.

Apply low emittance coating to the identified windows.

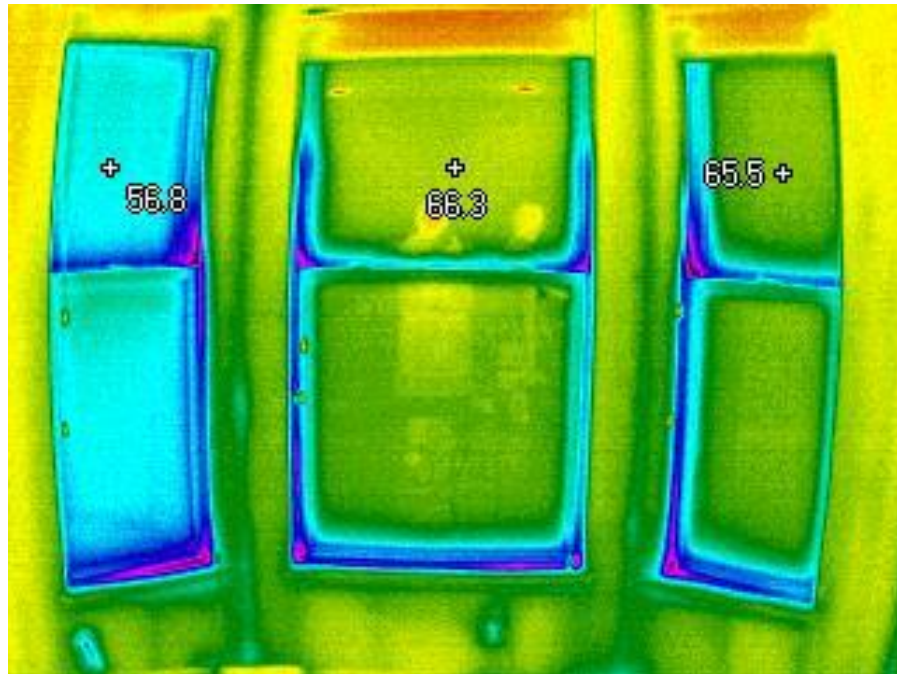
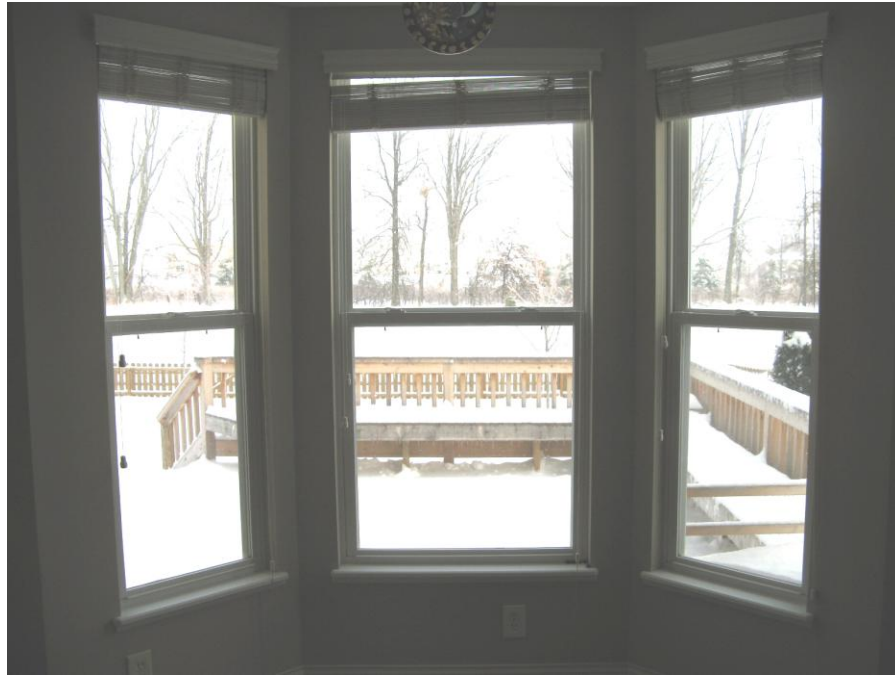
Illustration #25

- A. Thermogram indicates image non-uniformity and surface temperature variations between coated and non low E coated window (left side).

- B. Photograph indicates area in which above thermogram was recorded - Kitchen bay window.
