Mays Consulting & Evaluation Services, Inc.

INFRARED THERMOGRAPHIC SURVEY

JANUARY 30, 2009

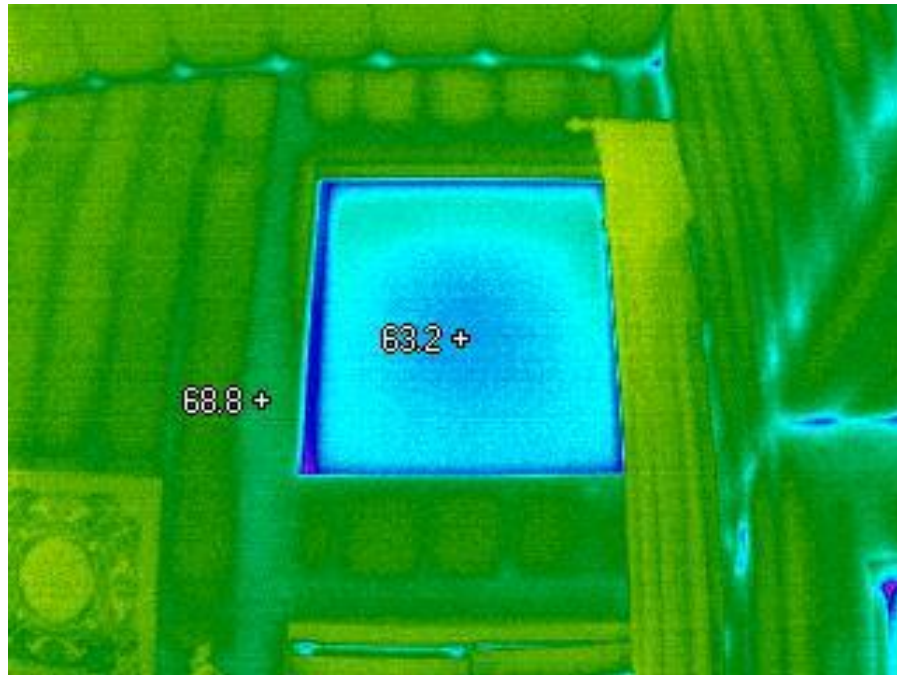
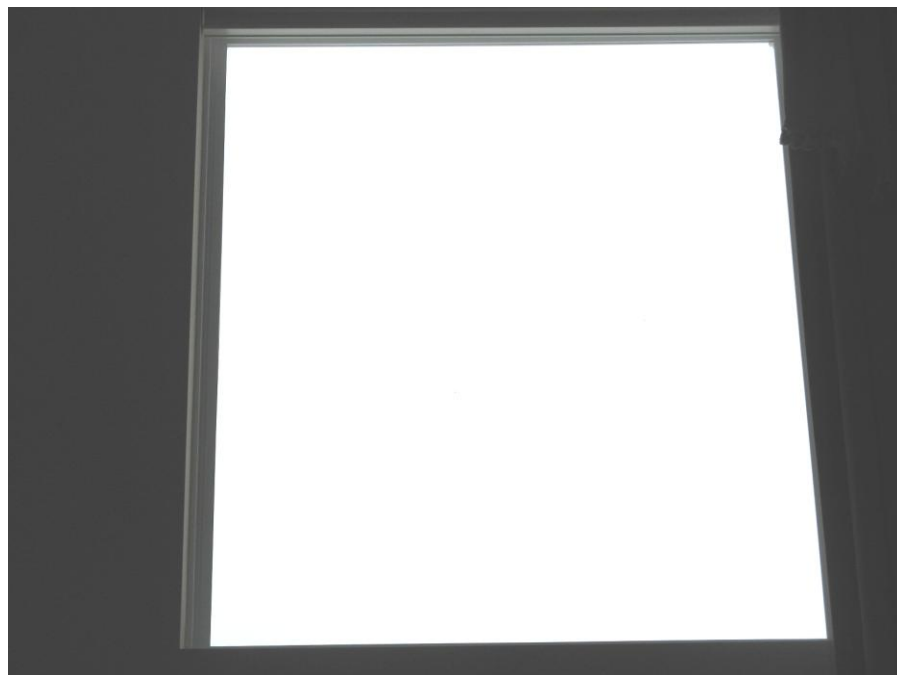
Illustration #21

The upper left side window within the Great Room north elevation was found to have a faulty seal (see illustrations #19 thru #22). As gas installed between the window pane leaks out through a faulty seal, the window panes compress, decreasing the R-value of the window. The result is substantially colder surface temperatures on the inside of the window in comparison to other like windows. This condition will also promote frost development on the inside of the window.

A. Thermogram indicates properly functioning window assembly as compared to illustration #20.

B. Photograph indicates area in which above thermogram was recorded - Great Room, north elevation.

The window assembly should be replaced.

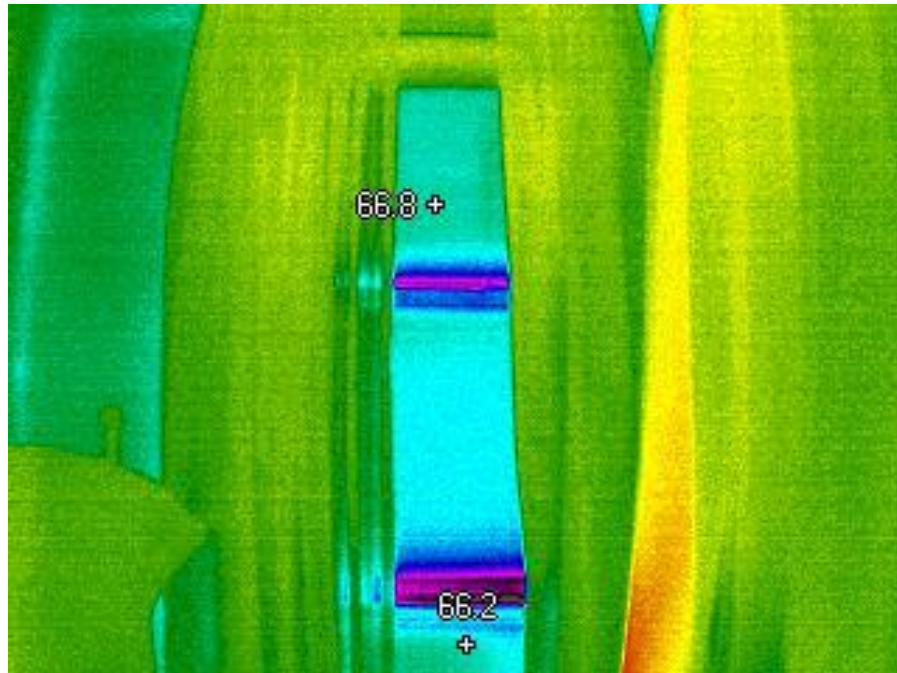
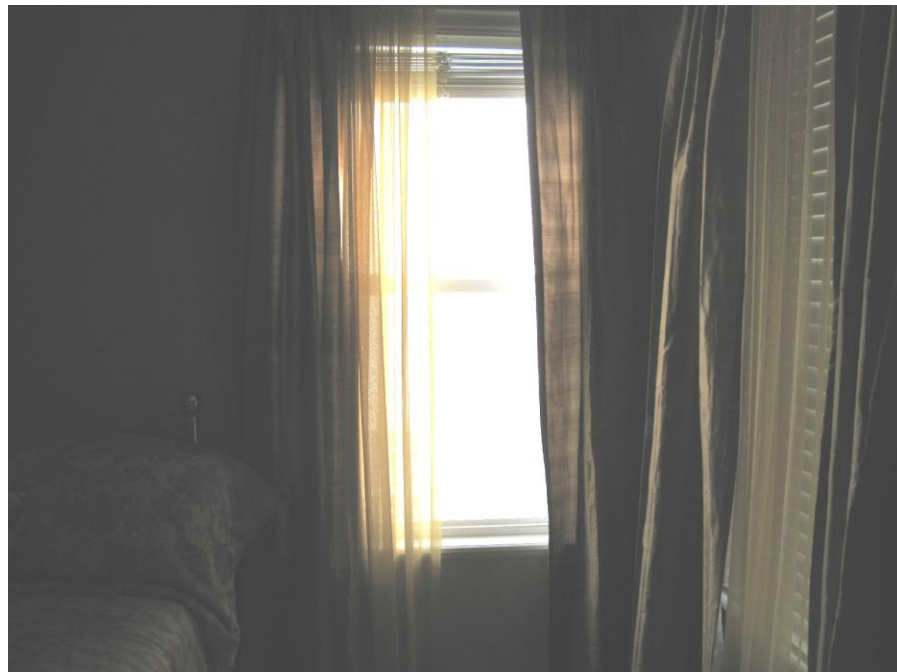
Illustration #24

- A. Thermogram indicates window with low E coating. Compare surface temperature differentials with illustration #23.

- B. Photograph indicates area in which above thermogram was recorded - Bedroom #2, west elevation.
